Bridge Inspection Report

Plainfield 177/096

CAMP ROAD

NEWTON BROOK

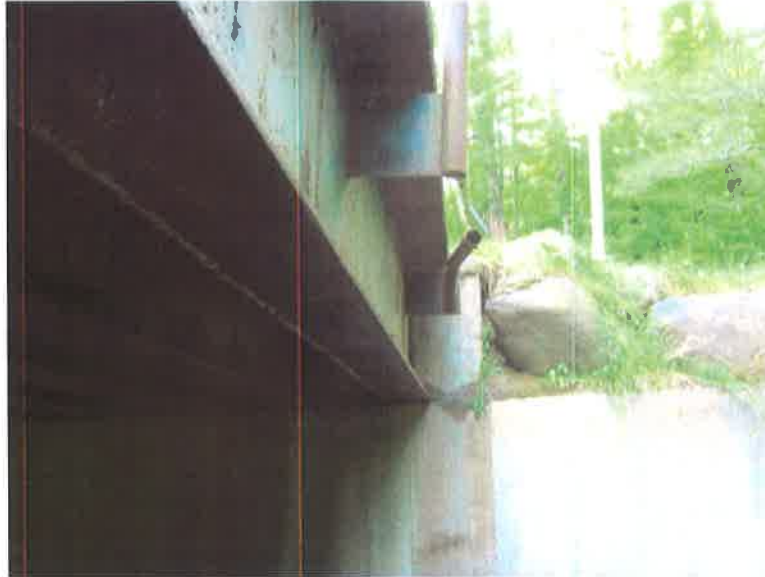
B563 36

W-BEAM RAIL: POSTS RUSTED, NORTHEAST POST BROKEN AND TIPPED BACK.

36. POST BROKEN AT NORTHEAST.

POST BROKEN AT
NORTHEAST.

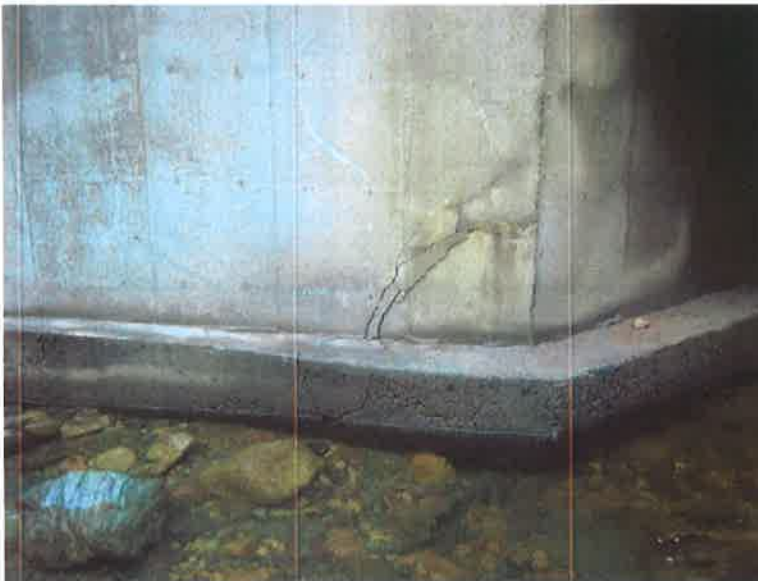
B563 37

37. CRACKS AND DELAMINATION AT NORTHEAST WING

CRACKS AND
DELAMINATION AT
NORTHEAST WING

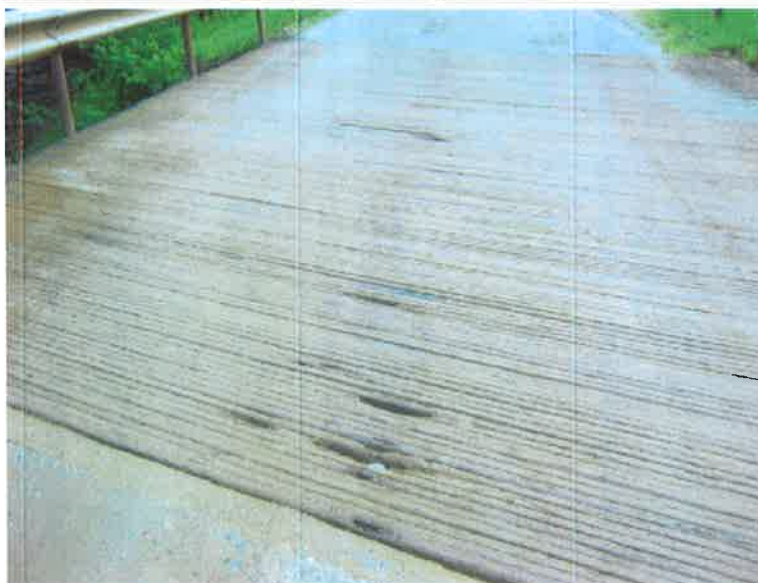
B563 38

DECK: MODERATE WEAR AND DAMAGE. GAPS AT SOUTH END. MODERATE AREAS OF DECAY.

38. MODERATE WEAR, DECAY IN TIMBER DECK.

MODERATE WEAR, DECAY
IN TIMBER DECK.

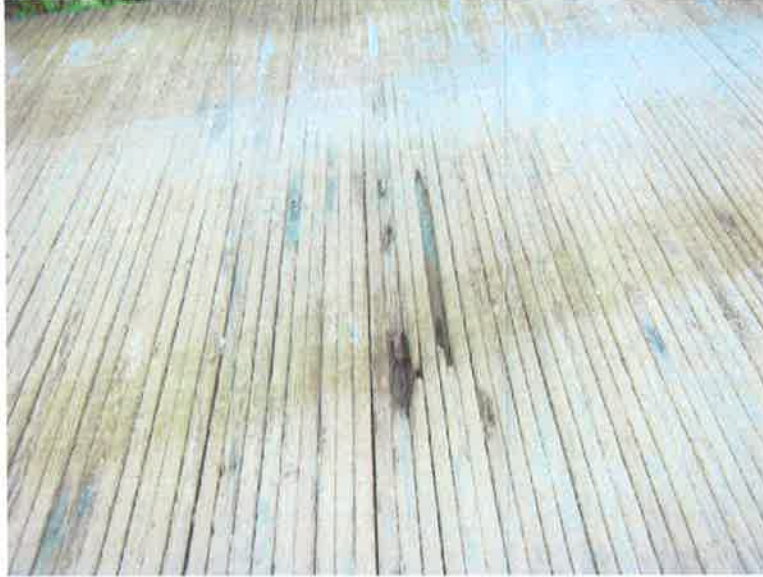
B563 39

39. MODERATE WEAR, DECAY IN TIMBER DECK.

MODERATE WEAR, DECAY
IN TIMBER DECK.
