January 23, 2015

EV #15006

Re: Town Highway Garage Building Structural Evaluation
Plainfield, NH

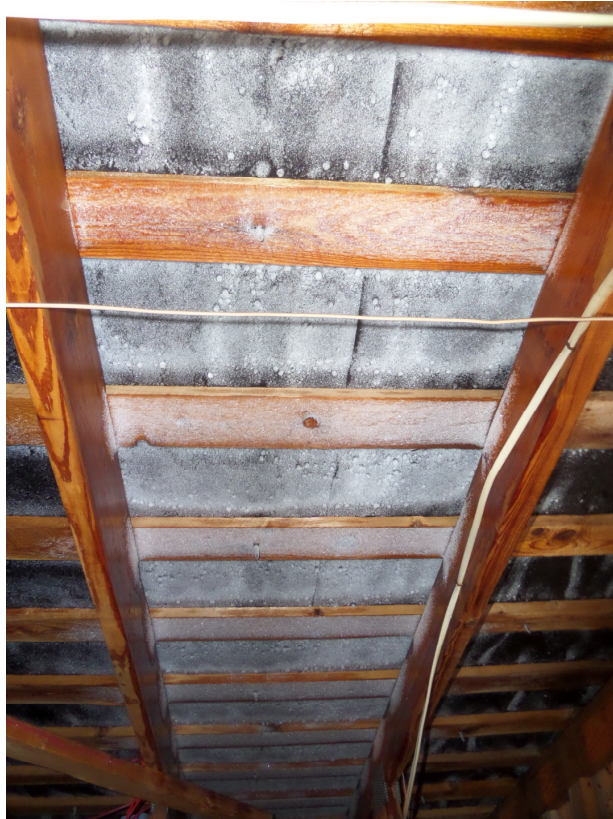
3. Corrosion of the roofing was observed in places.
4. While not structural in nature, condensation was observed beneath the asphalt paper near the gable ends of the building, (Figure 1). This is indicative of inadequate ventilation of the attic space. Vents were observed on the gable ends of the building but asphalt paper appeared to be obstructing the ridge area of the roof, (Figure 2). This obstruction would interfere with the proper functioning of a ridge vent system. I was not able to observe if a ridge vent was in place on this building. Proper vents were observed along the building eaves. However, I was not able to observe them closely and thus could not determine whether or not they were obstructed with insulation.

Figure 1 - Condensation near gable end of structure.

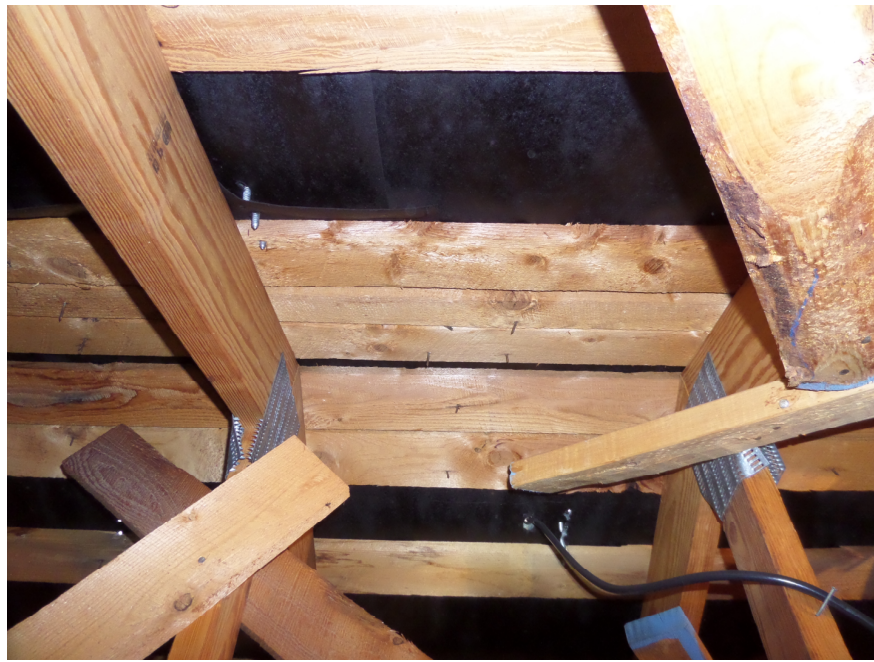
Figure 2 - Apparent obstruction of ridge vent.

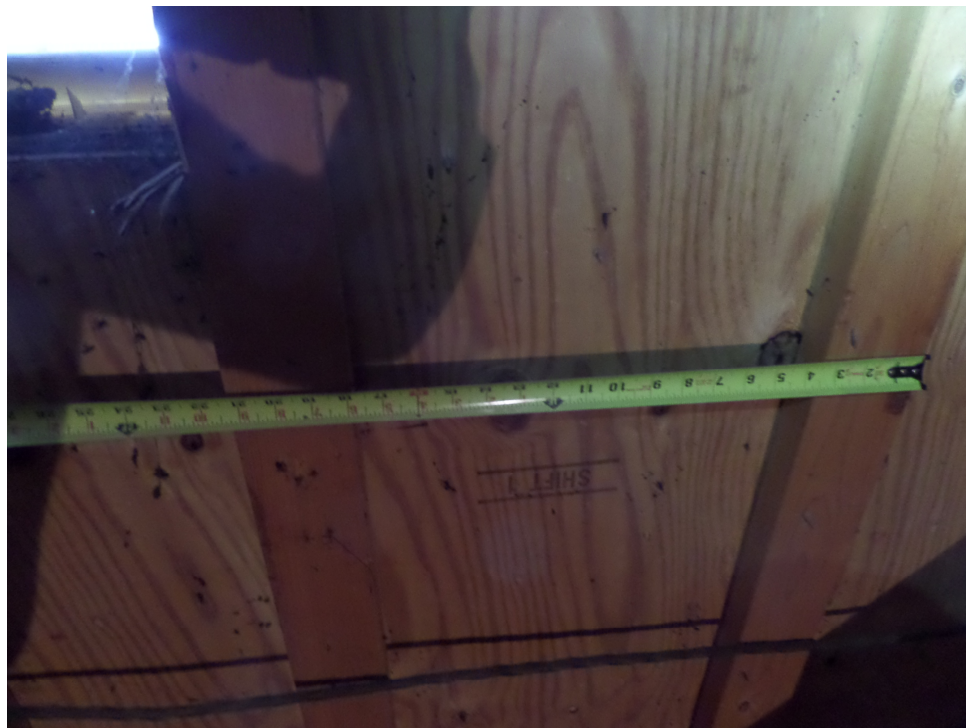
6. The gable end trusses (trusses at the east and west end walls) were not designed for or braced to withstand out-of-plane wind pressure. The framing between top and bottom chords consisted of 2x4 wood studs laid in the flatwise orientation, (Figure 3), which is structurally not adequate, particularly closer to the ridge of the roof. Additionally, the bottom chords of the gable end trusses, (the horizontal members spanning across the building at the ceiling level) were not observed to be properly braced back to the roof framing to support out of plane wind loads. Some truss erection bracing was observed to be tied into these gable ends but this is not sufficient to meet current code requirements. This bracing is important because the top of the building wall framing ties into the underside of this bottom chord and the effect of not having the bracing of this cord is to create a hinge point at the bottom chord.

Figure 3 - Gable end truss framing with flatwise 2x4's.

1. As per the Engineering Ventures report dated August 19, 2014, the existing metal roof is at the end of its design life and consideration should be given to its replacement. The trusses themselves should also be upgraded as per this report.
2. The new roof system should include plywood sheathing for diaphragm action and be designed with proper insulation and ventilation systems so as to eliminate condensation issues.
3. Hurricane ties should be installed as part of the roof replacement work as none are found to be currently in place.
4. The gable end trusses should be reinforced to support out of plane wind loads and a proper lateral bracing system for the gable end truss bottom chords should be provided.

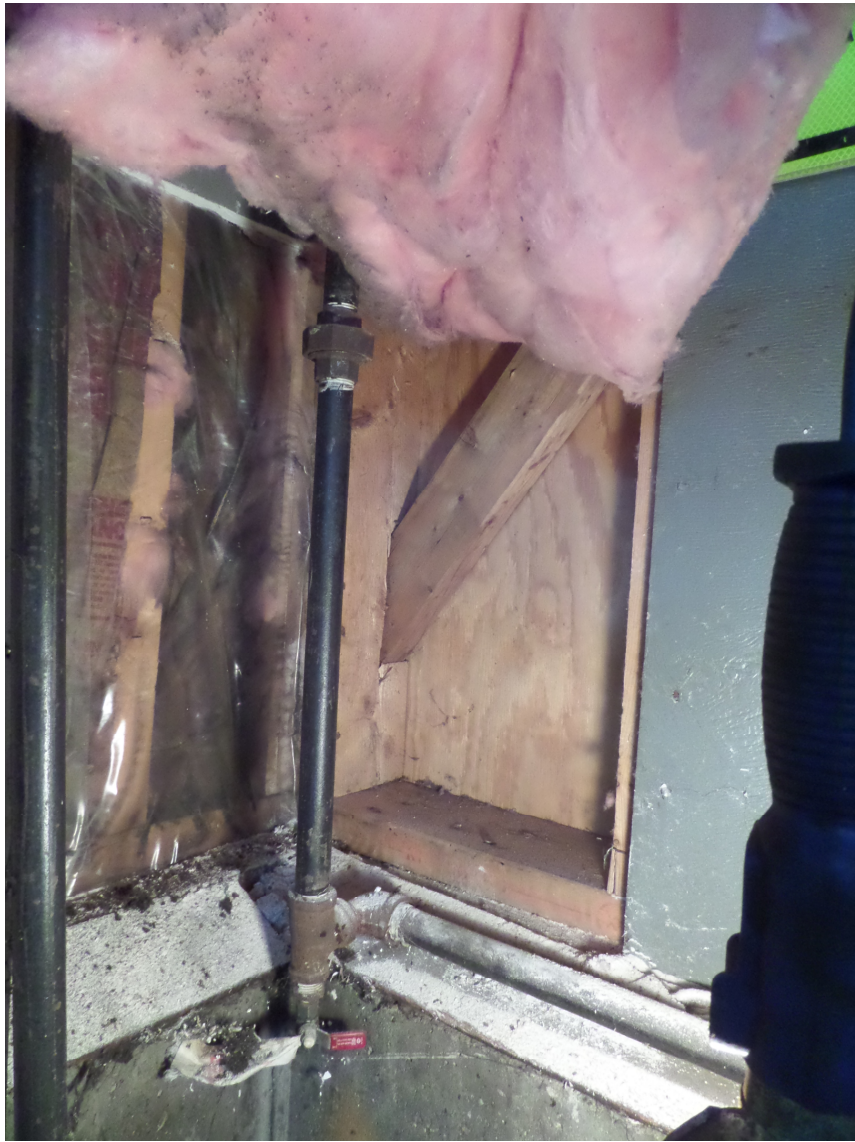
3. 2x4 Diagonal wood bracing was observed to have been let in to the wall studs, (Figure 4). This diagonal bracing was possibly intended to prevent racking of the wall assembly during erection. The bracing members have an actual width of 1 1/2 in. and current building codes permit a maximum notch depth of 1 3/8 in. into wall studs. Thus any wall studs which have been notched do not comply with current building codes. In the un-notched configuration and assuming a lumber grade of Eastern Hemlock – balsam fir No. 2, the wall studs would be structurally adequate to support current code-required loads. The extent of the wall studs which have been improperly notched could not be determined as the wall was concealed by finishes.

5. The bottom plate of the wall system consists of a non-pressure treated 2x6 sill plate, (Figure 4). The plate was observed to be in good condition. However, current building codes require that wood members which are in contact with concrete be pressure treated. Only minimal anchorage of the sill plate appearing to consist of powder actuated fasteners was observed during the January 12 site visit, (Figure 4). This configuration is insufficient for current code-required loadings as well as code-required loadings in place at the time of construction. The code also requires that the sill plate be attached to the foundation with anchor bolts or code-approved straps. Due to the relatively small portion of framing observed, it could not be conclusively determined that this was the foundation anchorage which was carried around the entire perimeter of the structure. Additional anchorage provisions are required at the edges of shear wall sections. It is assumed that this anchorage is not in place.

Figure 4 - 2x4 diagonal let in wall bracing and sill plate anchorage.

1. Aside from the vertical cracks observed along the north wall, the visible portion of the concrete walls appeared to be in good condition.
2. Due to the implementation of 2x diagonal bracing during construction, the wood studs have been notched to a depth which exceeds current code requirements. Any notched studs would have to be reinforced or replaced.

3. A pressure treated sill plate would need to be provided.
4. Sill plate anchorage would need to be designed and installed. This could possibly consist of epoxy anchor bolts embedded into the top of the foundation wall. The minimum prescriptive sill plate anchorage is ½" dia. Anchor bolts spaced not more than 6 ft. apart, (IBC 2009 2308.3.3), but more substantial anchorage may be needed for this application.

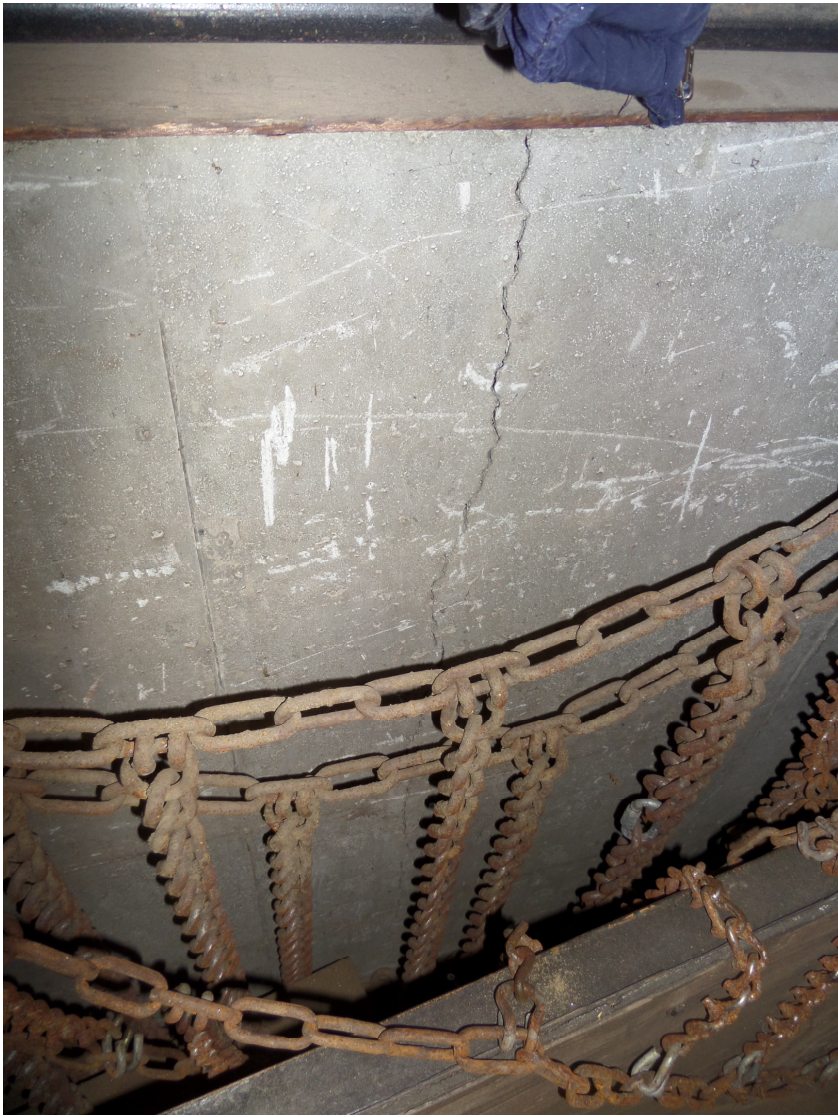
8. The concrete foundation wall consists of a 10 in. thick wall. A significant portion of the wall on the south edge of the building was concealed from view. However, cracks were observed at two locations along the portion of the wall on the north edge of the building, (Figure 5). The cracks extended from the top of the wall to the floor level. There was no differential movement observed at the crack locations and the foundation wall condition below the floor level was concealed from view.

Figure 5 – Crack in concrete foundation wall.

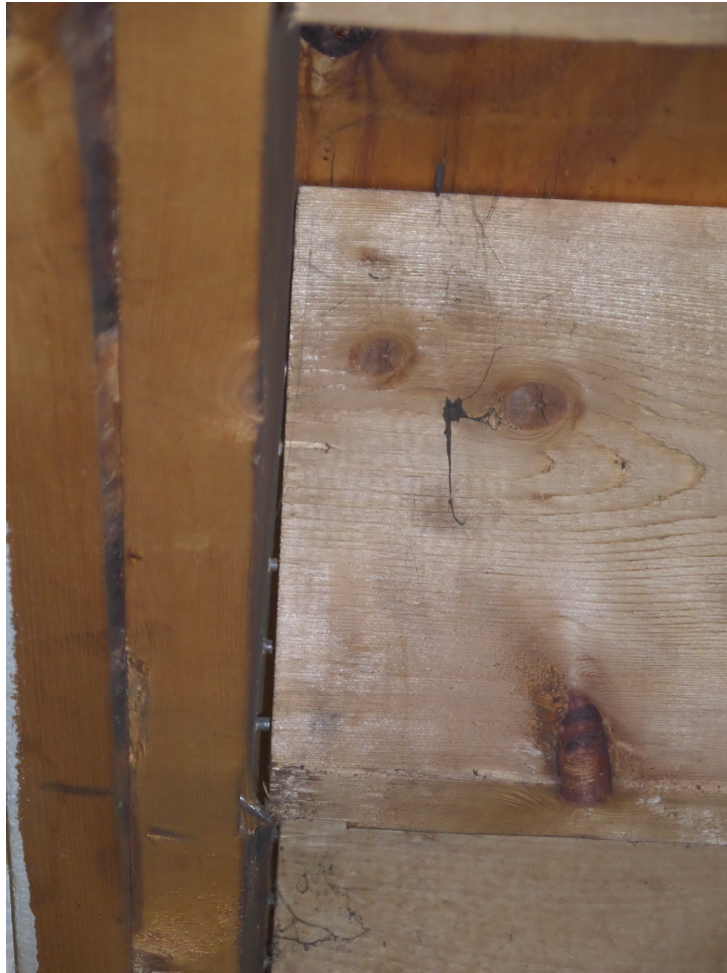
1. The mezzanine floor framing consists of wood joists at 16 in. o.c. spacing. An office area is framed with 2x10 joists and a kitchen/break area is framed with 2x8 joists. The current code-required design floor live loads for the office and kitchen/break area are 50 pounds per square foot, (psf) and 100 psf, respectively. Under these loadings, the office floor joists are structurally adequate. The kitchen/break room floor joists are adequate if the joists are two-span joists, (span continuously over three bearing walls). For the single span condition, (spanning between two walls) they are overstressed. The office floor joists frame into a ledger on one end and to a double 2x10 header on the opposite end. Both the double 2x10 header and the joist connection to it, (Figure 6) are structurally deficient. In Figure 6 it can be observed that the floor joist end has pulled away from the header.

Figure 6 - Office floor joist end separating from header.

1. Floor joists in the single span configuration beneath the kitchen/break area should be reinforced.
2. Face-mount joist hangers should be provided at the ends of the joists beneath the office area which frame into the side of the (2) – 2x10 header.
