New Hampshire Local Audit Exchange Program

# Energy Audit Report

## Philip Read Memorial Public Library

January, 2012

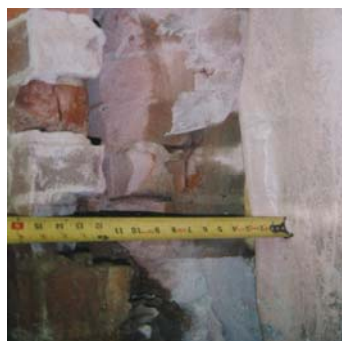
Both buildings were built on uninsulated slabs. The foundation wall in the old section is only visible in the furnace room which reveals a poured concrete foundation below grade supporting brick courses above. The photo below was scanned from an album of photographs of the 2003-2004 construction and suggests the brick is 16” deep. It also appears there may be an air space between the inner most courses and the outer layer. If this is the case, the air space prevents moisture wicking to the inside, which means the inner brick could be insulated without concern of trapping moisture and a freeze thaw cycle that can damage bricks. It is mentioned here in the event the interior of the foundation walls are ever exposed for any reason; it could be an excellent opportunity to insulate the interior of the foundation wall. The recommended thickness would depend on whether that air space exists or is an optical illusion.

Photo from 2003

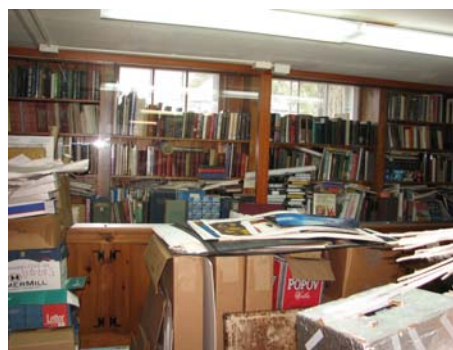
Archival book cases

As it is, most of the 100 lineal feet of exterior foundation wall has been covered in wood panel and these glass case bookshelves which would add significant cost to move in order to insulate the walls. It is important to note that this appears to be working as archival, which would support

the theory of an air space in the courses of brick and or the presence of some sort of moisture barrier between the earth and the interior environment. There is likely significant heat loss, especially through above grade brick, but without noticeable moisture problems occurring in the collections, insulation would not be cost effective at this time. It is discussed here because the fact that its working so well – and is such a creative use of space, including the day lighting, it indicates that the basement is kept warm enough to prevent condensation and/or the dehumidifier is effectively managing moisture loads. Changing either one of those things may increase the risk of moisture damage.

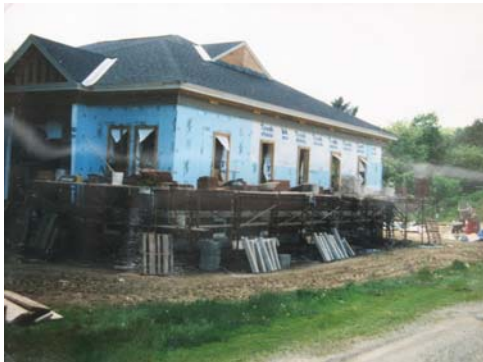
This is important to understand when deciding whether to add continuous insulation in the basement as well as around the concern about condensation occurring - especially in cold areas such as shown (darker areas) in the IR image to the right. Condensation occurs when vapor comes in contact with a surface at or below the dew point of the air temperature – such as a bathroom window or mirror during a hot shower. Imagine moisture in the air moving through a gap in the plastic vapor barrier – around an outlet for example – and moving towards the colder, drier air outside. When it gets to the sheathing, or the edges of a metal stud, the air will cool and if drops below the dew point,

the vapor its carrying will change to liquid water. Too cold too dry to the outside, and the vapor barrier will prevent any drying back to the warmer interior. And that's the beginning of rot and mold. The risk may be mitigated in this case by an “air infiltration” barrier which was specified in the drawings to the inside of the rigid foam. If installed correctly, this would reduce the likelihood and amount of air transported vapor from entering the wall cavities in the first place. The 2012 code recommends R7.5 continuous insulation for Zone 6, though a minimum of R15 is recommended by building scientists so that the exterior sheathing (and everything to the inside) will always remain above the dew point. In other words, vapor may still get into the wall, but it will remain as vapor. It is also recommended to NOT put plastic or any vapor retarding material to the inside, so that any vapor that gets in – can dry back to the interior.

While this kind of information is not typically part of a Level II energy audit, this is an important aspect of this wall assessment: For both the heat loss from thermal bridging through metal studs and the possibility of condensation occurring on cold, enclosed, and plastic covered surfaces. And it is the background on the recommendations for the not yet finished basement walls.

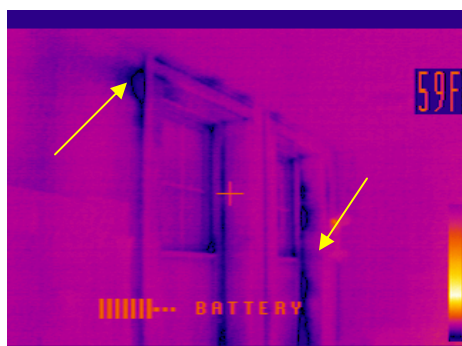
There are 55 wood, aluminum clad windows in the newer building with a total surface area of 511 square feet and a window to wall ratio of 17%, very close to the same proportions in the older building. The Eagle windows have ½ inch air space between two panes of glass low e and trademarked Maximizer Plus coating. The top sashes of double hung windows are the same three over three over one to match the older windows. Awning style windows exist in foundation walls near grade. IR scans suggest there is greater air leakage around these more recently installed windows, which is one of the concerns regarding vapor migration. The windows are made by Eagle and if meeting the specification of the plans, have a performance u-value of .33 or R3. New window glazing is responsible for approximately 10% of the building's conductive losses (excluding air leakage).

**At -20 pascals, new windows have substantial air leakage around the sashes as well as through the rough window openings.**

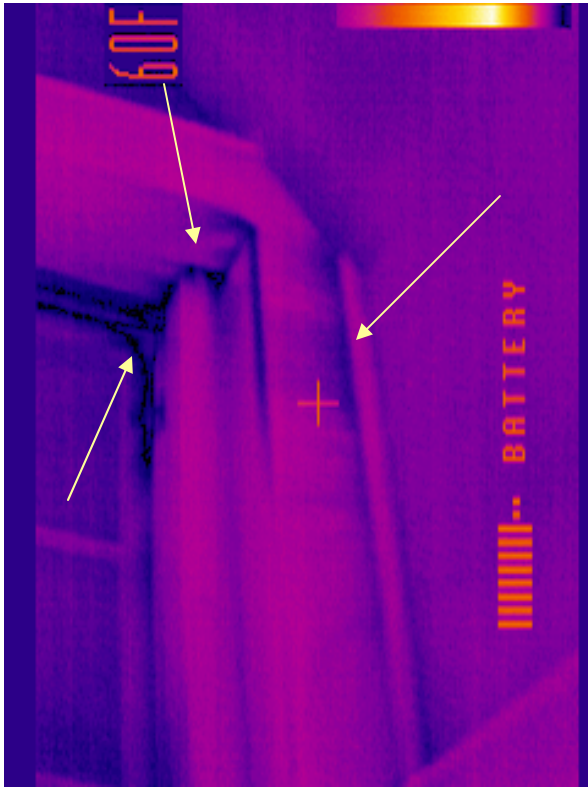
# Air leakage sites

1920 walls have plaster on brick and no insulation
