New Hampshire Local Audit Exchange Program

**Energy Audit Report**  
**Plainfield Highway Garage**

January, 2012

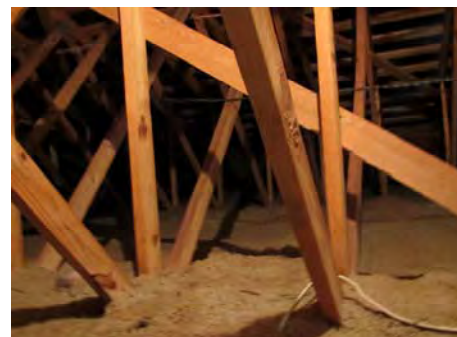
**Cellulose ‘topping’ over fiberglass batts, trusses and roof strapping**

The thermal barrier at the ceiling plane of has several deficiencies and there are several possible approaches that would reduce energy costs within a fairly reasonable time period. Targeted air sealing of all penetrations, including wires, equipment supports, and metal flashing around the chimney, is an important first step before adding insulation. Foam sealing on top of and around perimeter top plates is also key to form an air barrier. Ideally, all fiberglass would be removed and an even layer of 18" cellulose installed. The added costs typically extends the payback period though it is unquestionable the superior strategy for the long term. For a less costly approach, blow cellulose on top of what is there. This will create air pockets and compress the existing fiberglass which

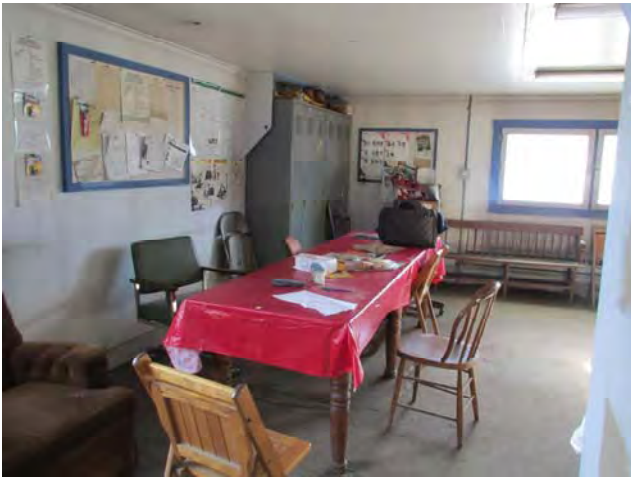
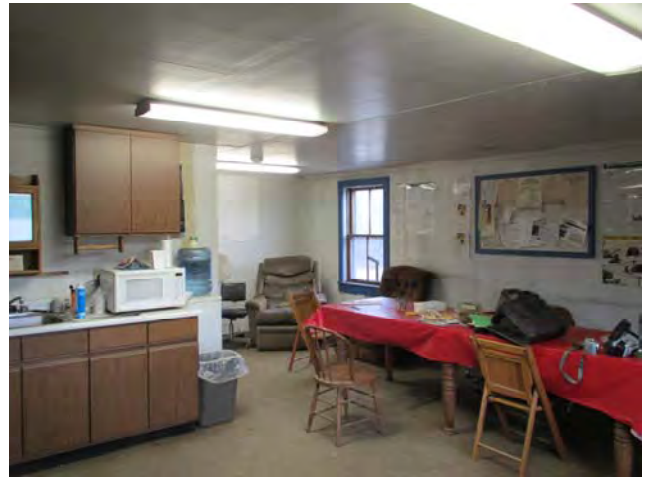
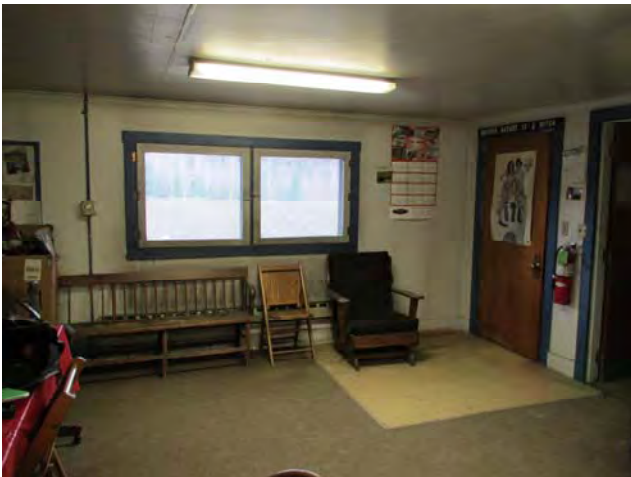
Office overlooks equipment bays

Cellulose topping over 6" fiberglass batts

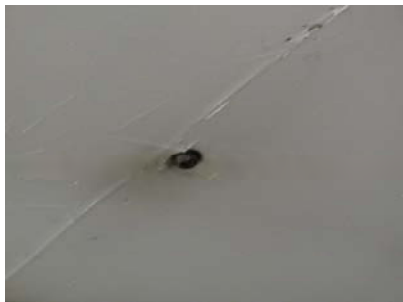
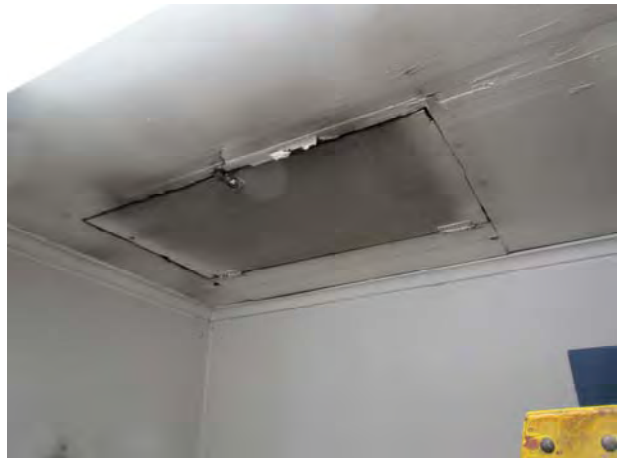
Attic access

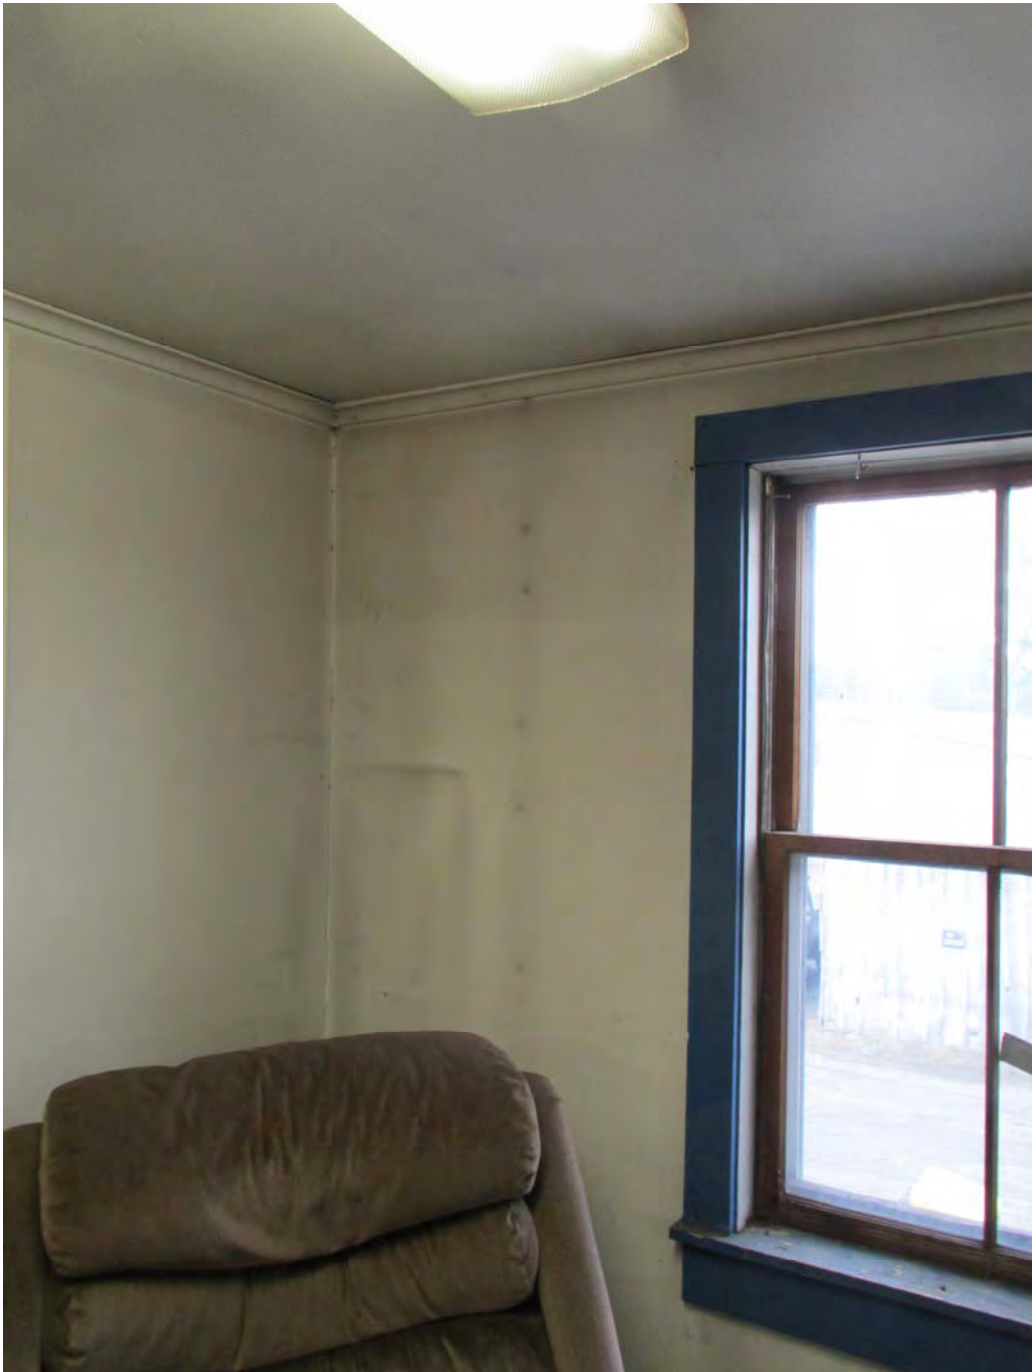
Note the faint staining on walls and ceilings, where studs and joists are located. Thermal bridging, and cold corners, means these areas will be colder and dirt in the air adheres to light condensation

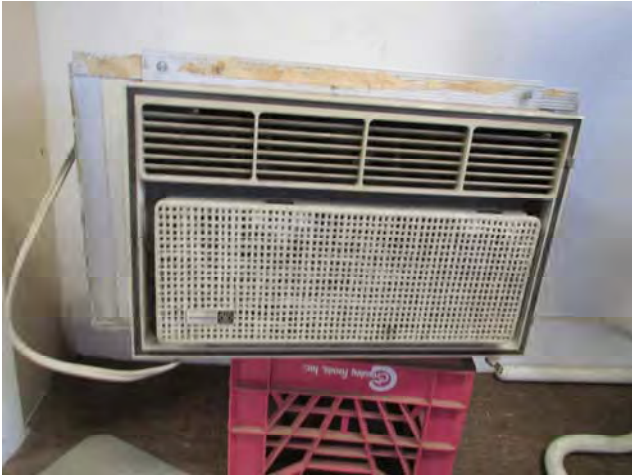
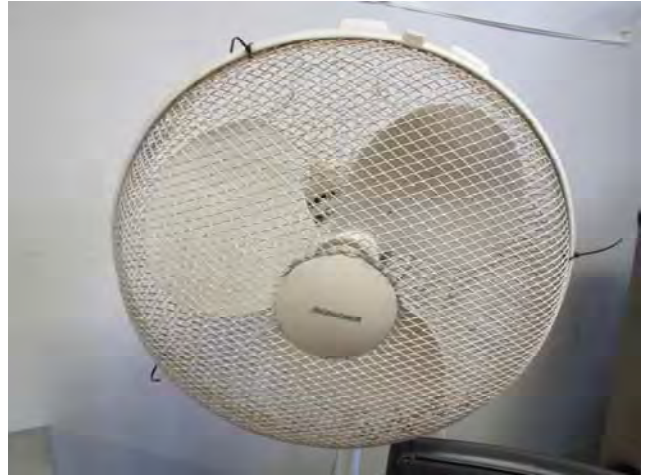
An old window air conditioner, floor and ceiling fans provide some relief from summer heat.

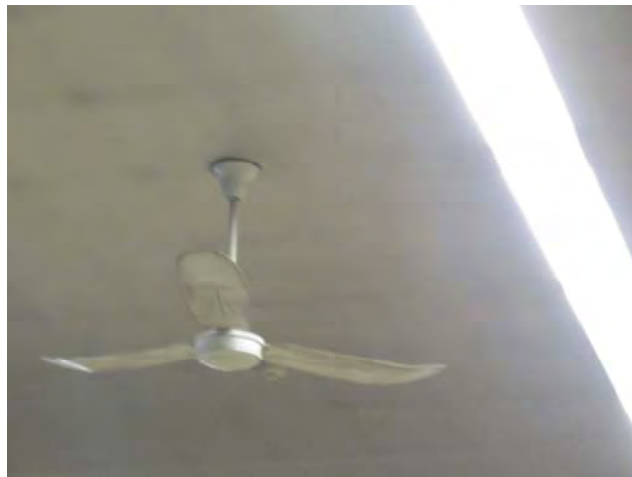
The primary source of heat is the 1998, 450KBtu, ceiling mounted Jackson and Church furnace (bottom right). It has two to three times the heating capacity needed for the building and is able to warm apparatus room without distributing through ducts simply because of the amount of heat it can put out. Electric resistance baseboards are installed in the downstairs lavatory and common room on the upper level to supplement warmer temps in those spaces.

2. Consider replacing the existing furnace with a more efficient waste oil furnace. Again, the Town of Danville has had good success with their new waste oil furnace, though the success depends entirely on the availability of waste oil in the town or area. It should also be made clear that this does not reduce GHG emissions and may even increase pollution to some degree. An EPA study has been included as Appendix D. The existing furnace is not old enough to warrant replacement, but it is considerably larger than necessary which decreases its efficiency. Replacement at this time would be most justifiable if it was to a furnace which could burn waste oil (no cost) or a blend of waste and #2 oil.

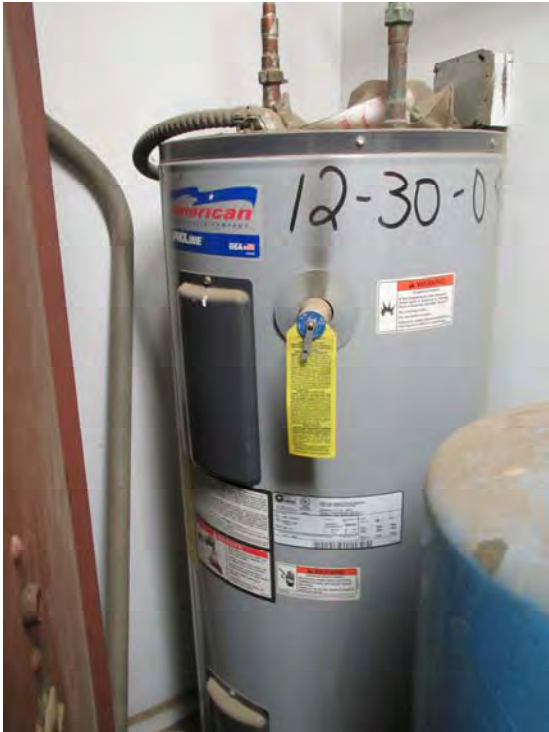
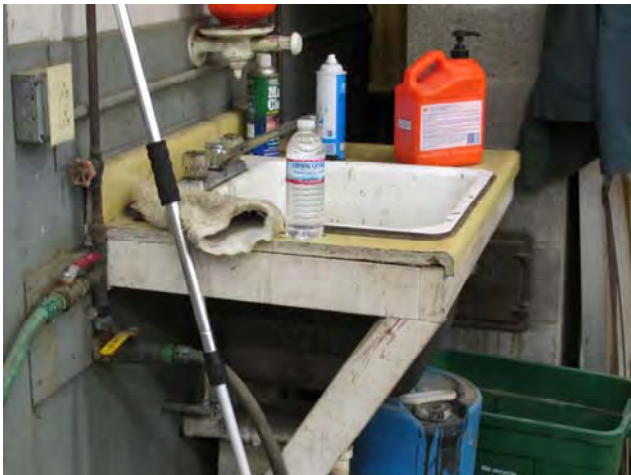
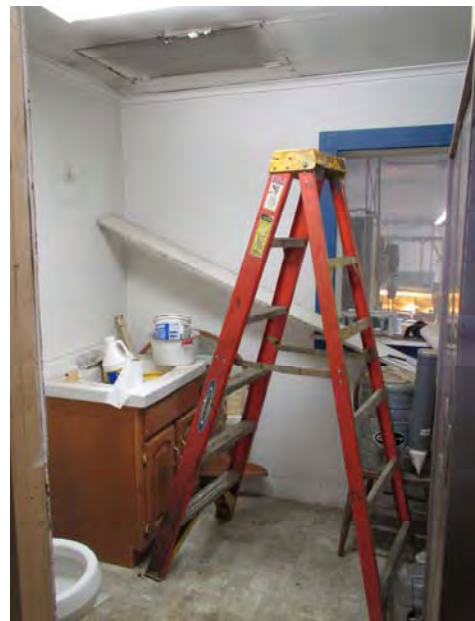
Domestic hot water for hand washing, and possibly a shower in the future, is provided by the 40 gallon electric hot water heater below.

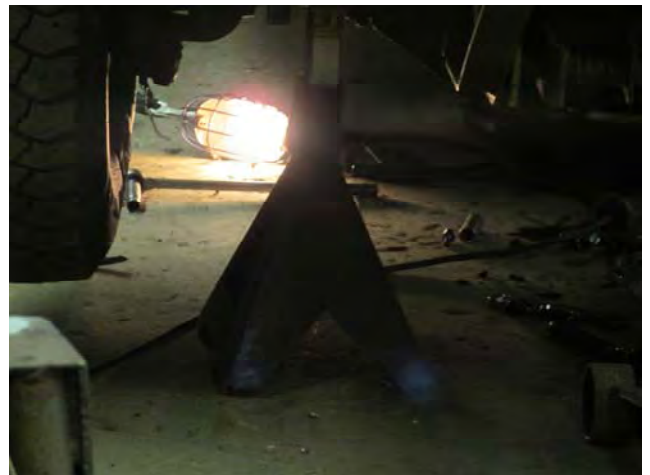
Eight corded drop lights provide excellent task lighting.

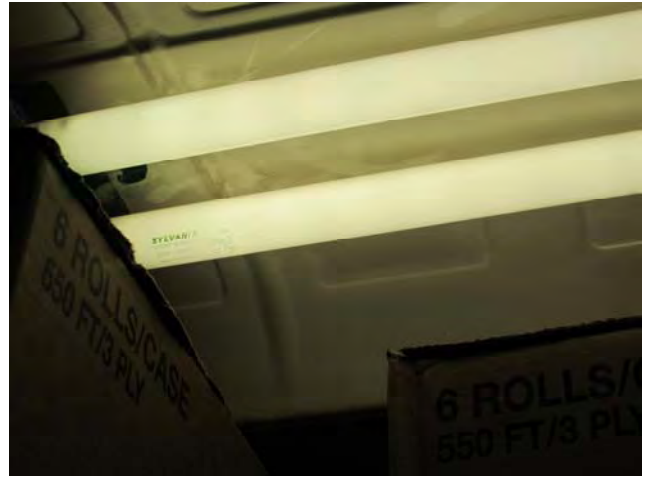
30W 4100K Sylvania supersaver ecologic 3

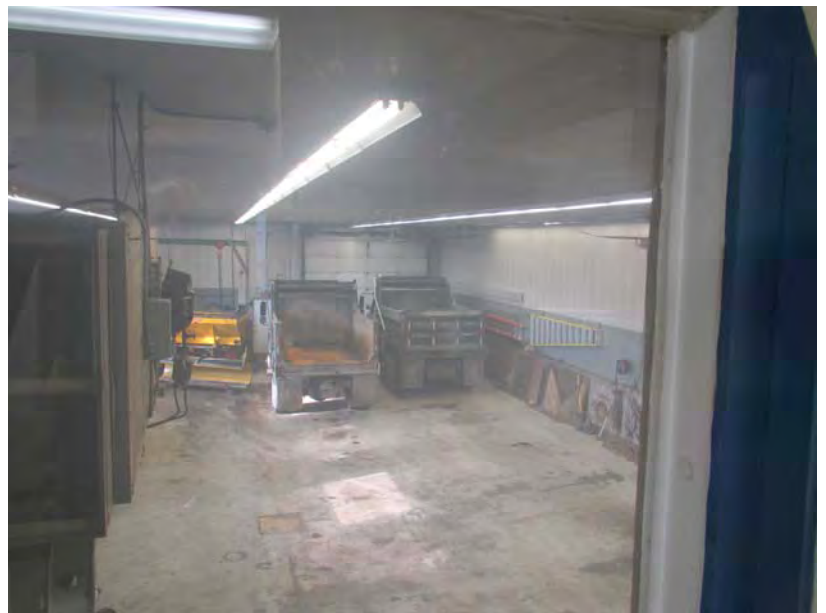
Mechanical ventilation is limited to two exhaust fans (above). On the day of the site visit, CO<sub>2</sub> level was just above the recommended 1000ppm maximum and air quality was visibly poor. Air quality in many if not most DPW buildings in the state is generally very poor. Conventional fresh air ventilation comes with a high energy penalty and standard filtration systems on heat recovery ventilation systems cannot handle the amount of contaminants in the air.

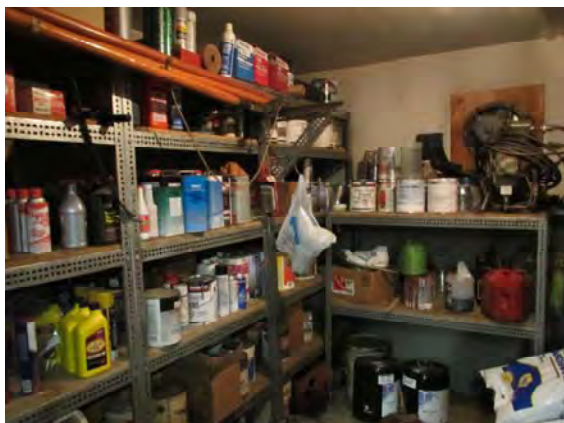
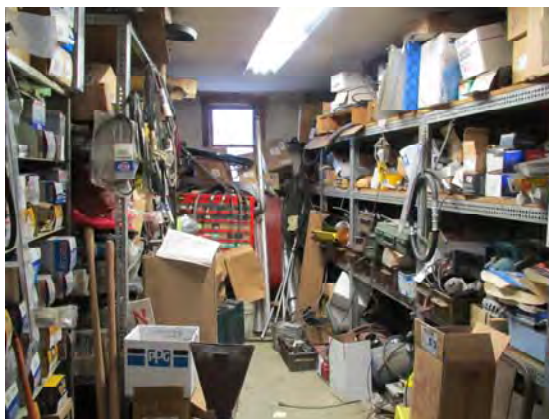
Solvents, products with volatile organic compounds (VOC's), gas and diesel fumes, and other chemicals all contribute to overall air quality in a DPW building

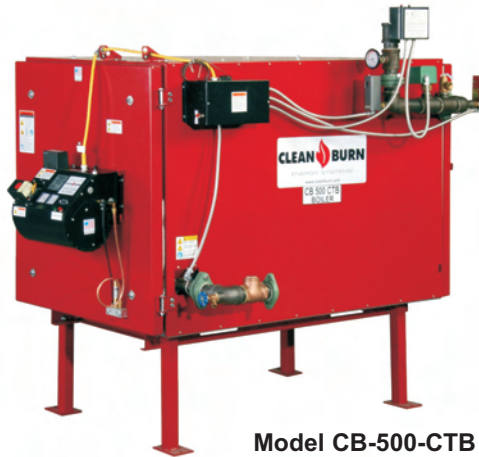
**Model CB-500-CTB**

Clean Burn offers the industry's only coil tube boilers engineered from the ground up to burn used oils. They efficiently recycle used oils as a free fuel source to generate hot water, and are remarkably versatile for a wide range of applications, such as car wash facilities, baseboard heating, space heating, in-floor heating and ice melt applications.

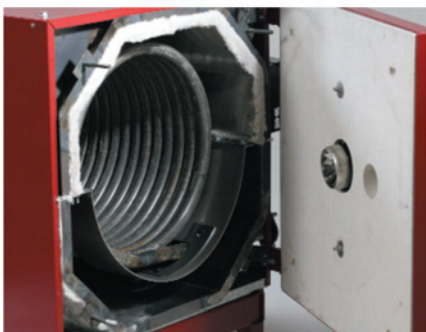
#### **Easier maintenance**

With Clean Burn Coil Tube Boilers, you spend 30 minutes cleaning every 750-1000 hours of operation. With competitive units, you spend 2 hours cleaning every 400 hours of operation.
