MERIDEN LIBRARY - MERIDEN, NH

PROJECT
 Meriden Library Replacement
 Plainfield, New Hampshire

JOB LOCATION:
New Building for the Meriden Library
22 Bean Road Meriden, New Hampshire
MERIDEN LIBRARY

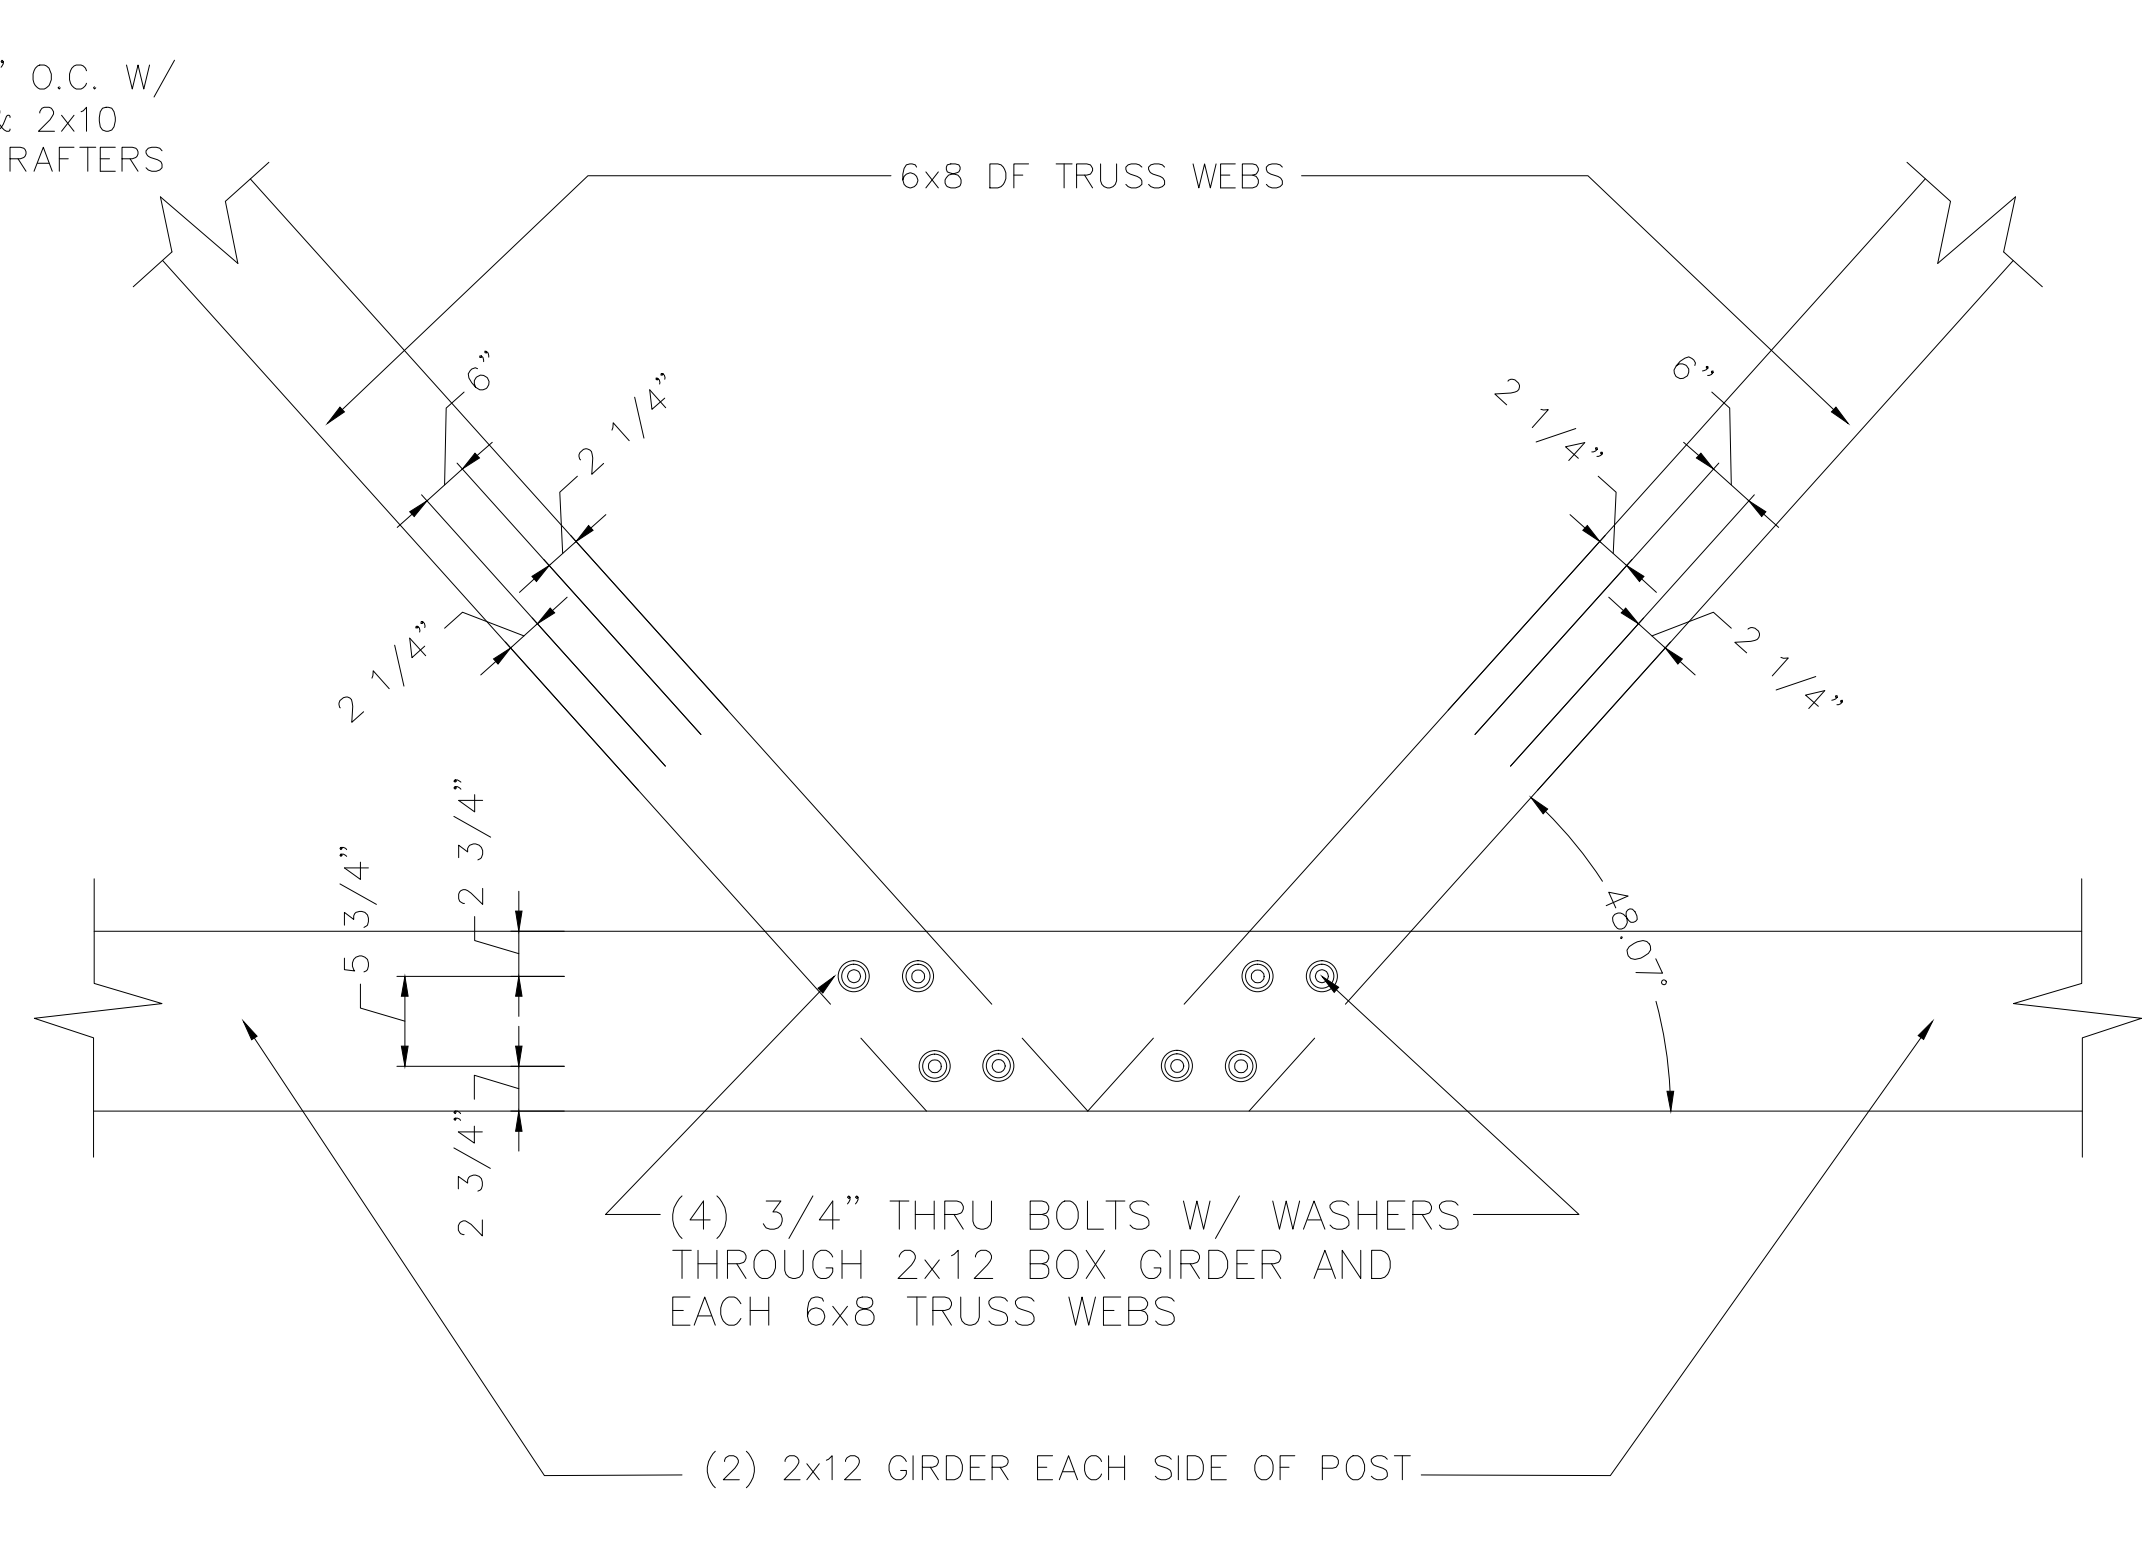
DETAIL 2

TRUSS WEB CONNECTIONS TO BOTTOM GIRDER AT COLUMN LINES B THROUGH G
