re: Concrete samples from the Plainfield Town Garage

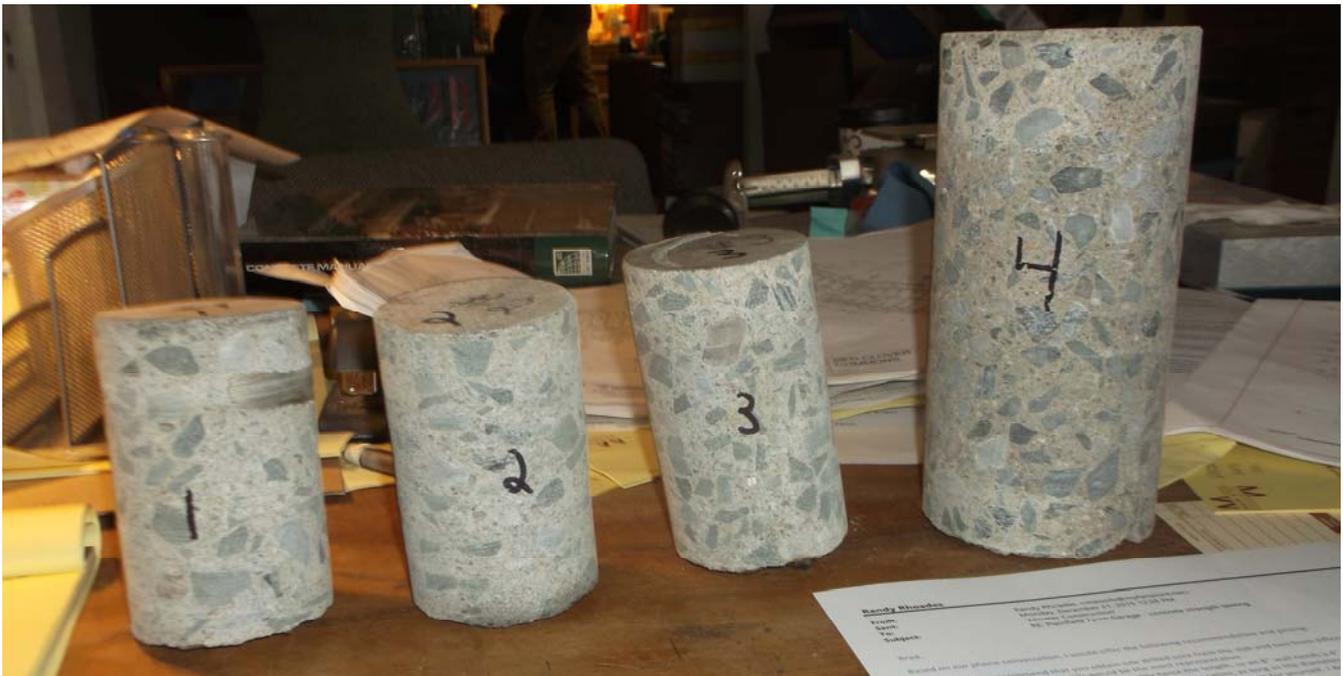
Cores 1-3 were 2 3/4" diameter, taken from the slab, and Core 4 was a 3 3/4" diameter core taken from the wall. I took initial measurements and photos of the cores before we disturbed them. A visual inspection of the cores showed what appears to be a 3/4" aggregated concrete mix, in all samples, that had been air entrained. Also visible was #4 bar reinforcing in the side of Core #1, at 1" down from the top of the core, and welded wire mesh in Core #3 at 3 1/4" down from the top.

A photo of the cores as delivered follows below.
